Error 19 oplossen bij de Urban E600 ebike

Fixing Error 19 on the Urban E600 ebike

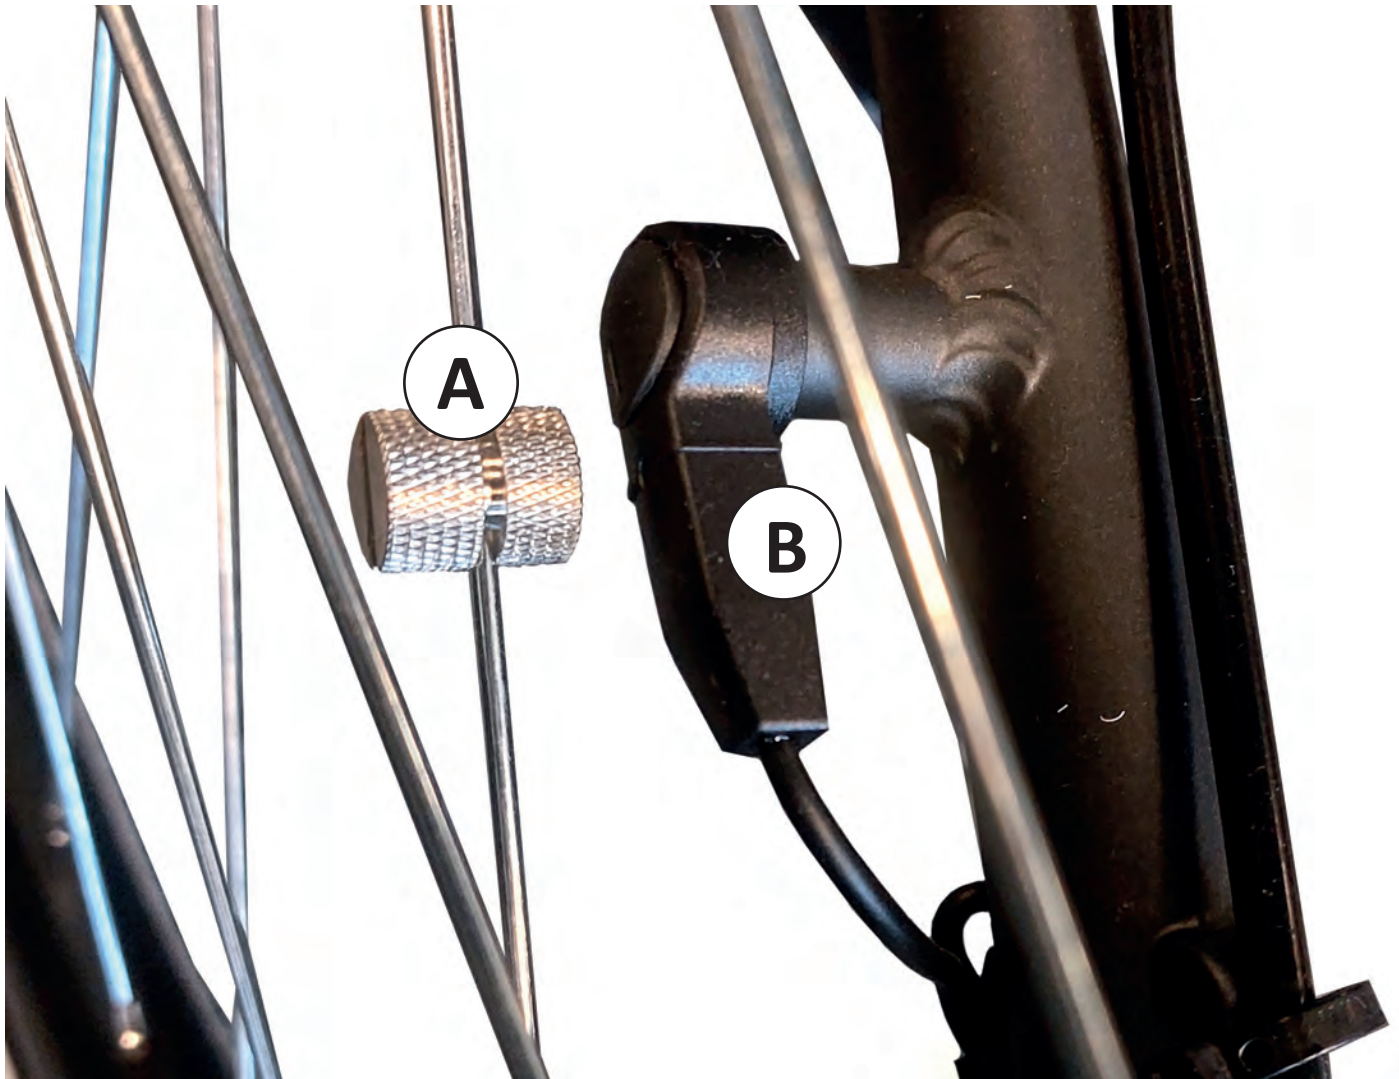
Wanneer het display van uw Urban E600 'Error 19' aangeeft is dat vrijwel altijd te wijten aan het feit dat het magneetje, dat als een soort geribbeld tonnetje (A) aan de spaak is geschroefd, niet goed uitlijnt met de sensor (B) die aan het frame is bevestigd. Soms kan door het vervoer of andere oorzaak het 'tonnetje' langs de spaak omhoog of omlaag zijn geschoven. U kunt het tonnetje een beetje losdraaien met een brede schroevendraaier of met de hand, en dan langs de spaak schuiven totdat het tonnetje in het midden langs de sensor gaat wanneer het wiel draait. Zie afbeelding boven. Draai het daarna stevig vast, zodat het op die plek aan de spaak blijft zitten. Nu zou de trapondersteuning weer probleemloos moeten werken.

When the display of your Urban E600 shows 'Error 19', it is almost always due to the fact that the magnet, which is screwed to the spoke like a ribbed barrel (A), is not properly aligned with the sensor that is attached to the frame (B). Sometimes transport or other causes can cause the 'barrel' to slide up or down along the spoke. You can loosen the barrel slightly with a wide screwdriver or by hand, and then slide it along the spoke until the barrel passes the sensor in the middle when the wheel turns. See image above. Then tighten it firmly so that it stays on the spoke at that spot. Now the pedal assistance should work again without any problems.
